TOWN OF MEDFIELD

Municipal Facilities

Evaluation and Capital Plan

October 6, 2017

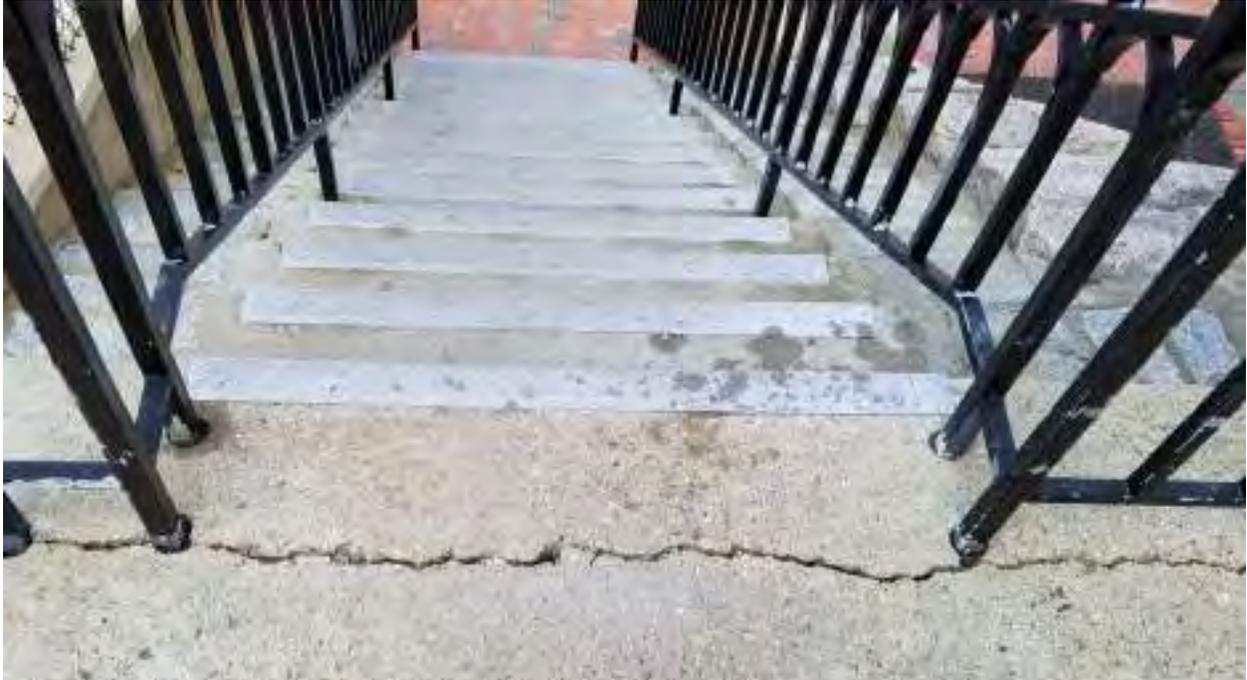
CONCRETE STAIRS & HANDRAILS FROM LOWER (REAR) LEVEL TO MAIN STREET ENTRANCE LEVEL
(Note crack at top tread)

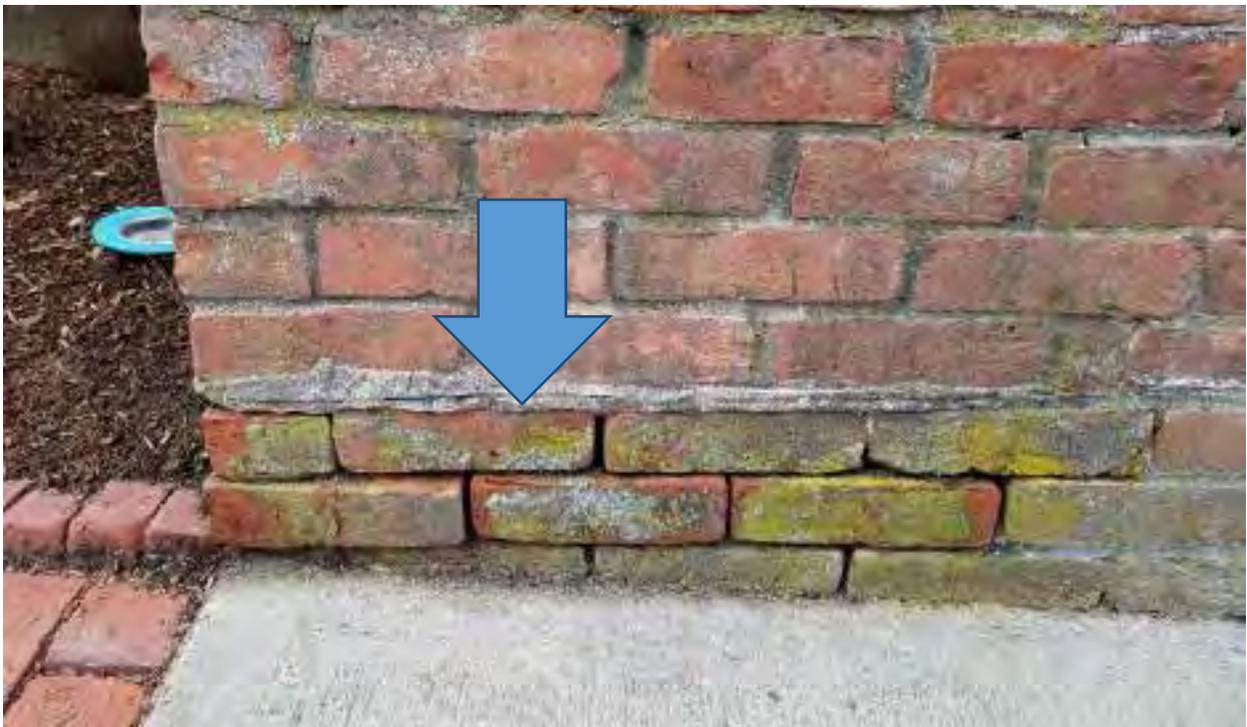
LOOSE BRICK AND TYPICAL ORGANIC GROWTH ON EXISTING BRICK

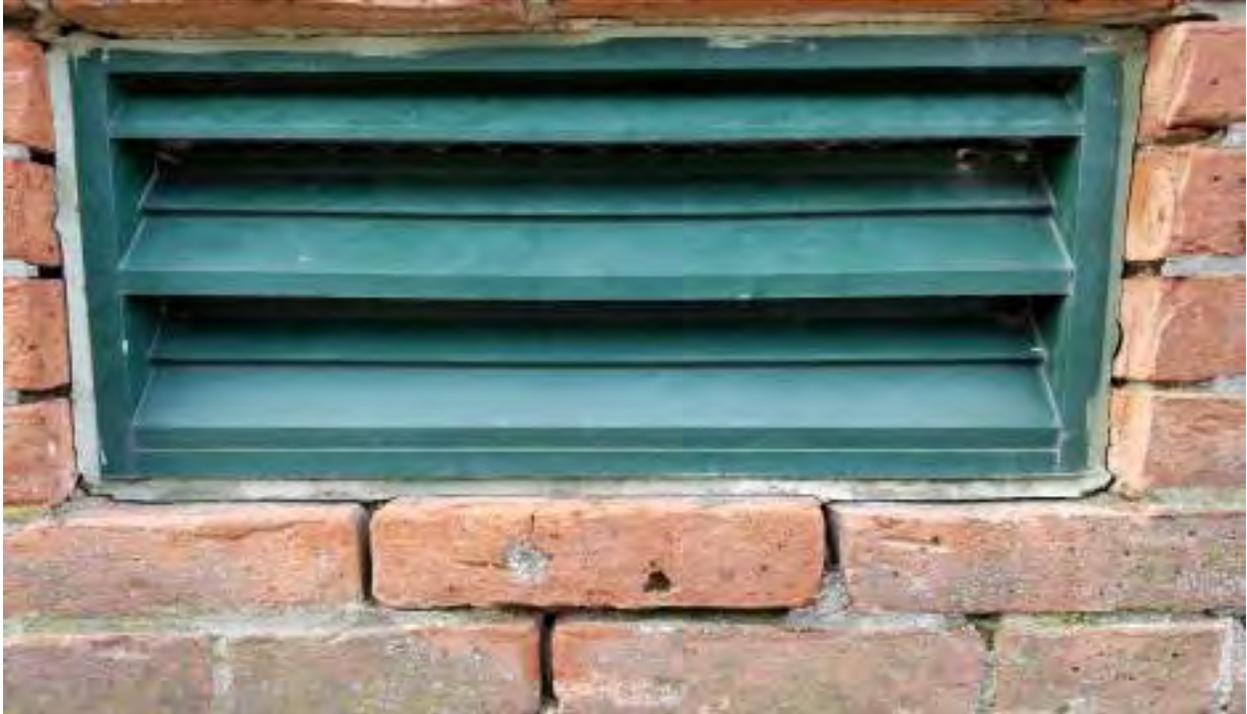
OPEN JOINTS IN BRICK AROUND OPENINGS CREATED DURING 1998 RENOVATIONS

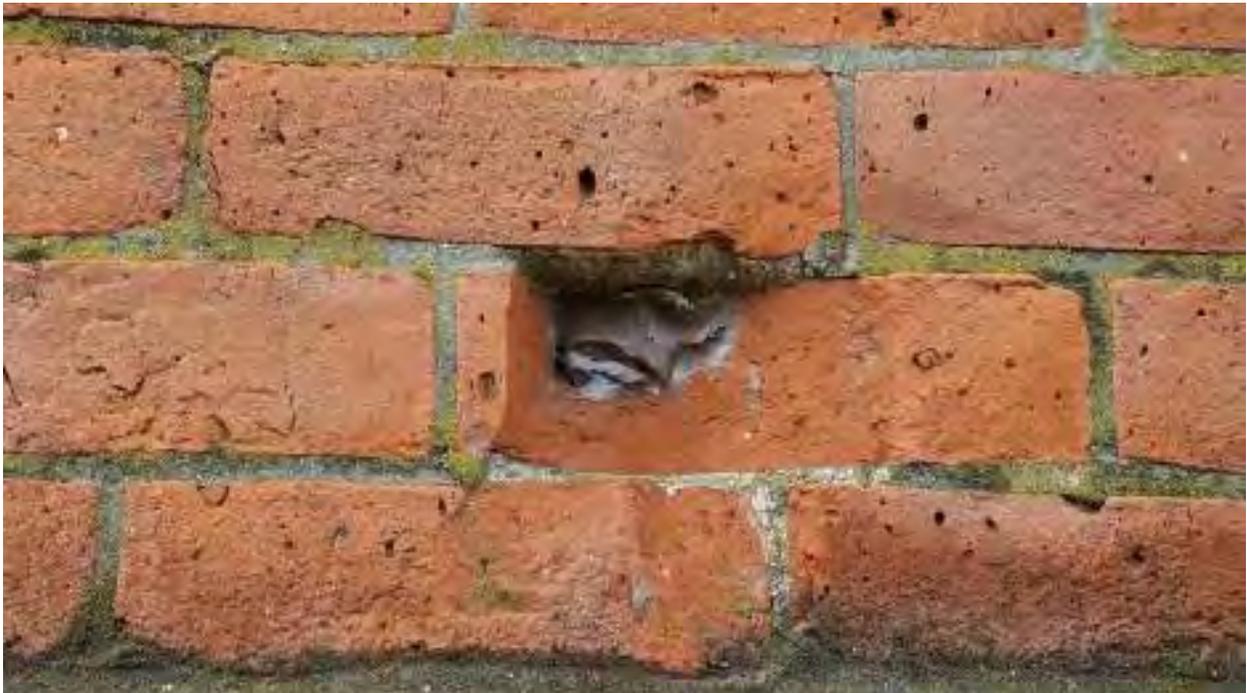
TYPICAL EXAMPLE OF SPALLED BRICK NEEDING REPLACEMENT and GROWTH ON BRICKS & MORTAR

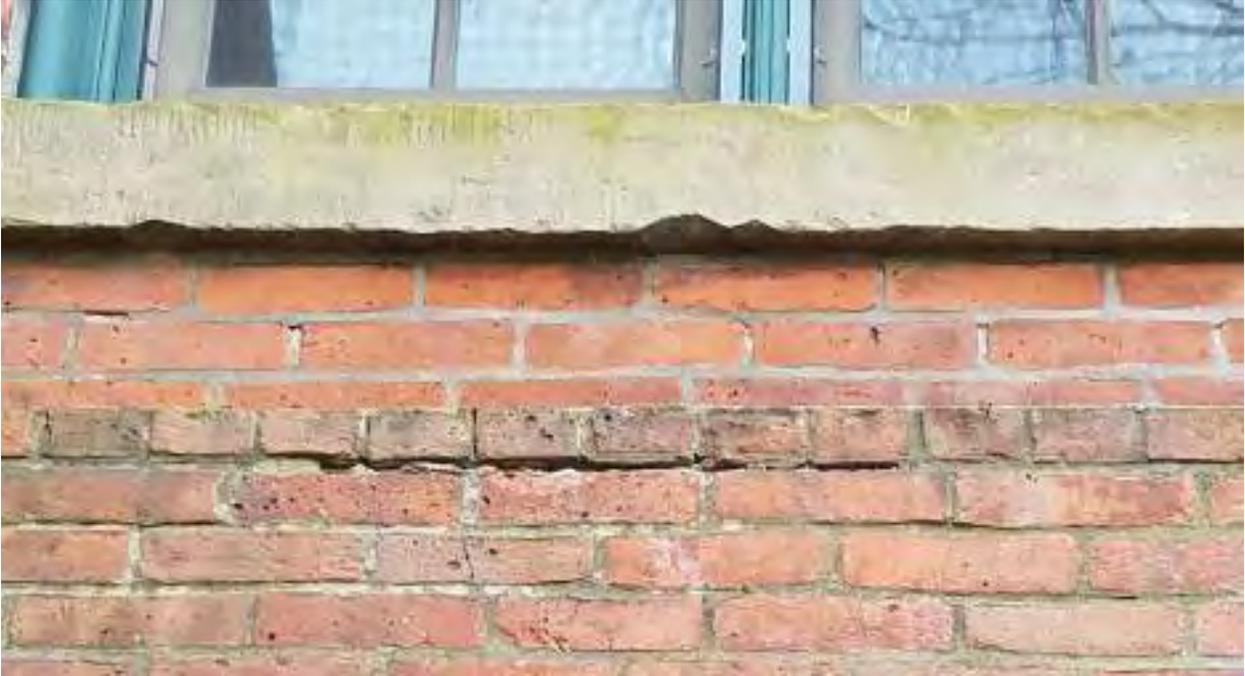
TYPICAL EXAMPLE OF DETERIORATED LIMESTONE SILL and OPEN JOINTS AT INTERMEDIATE WATER TABLE BRICK

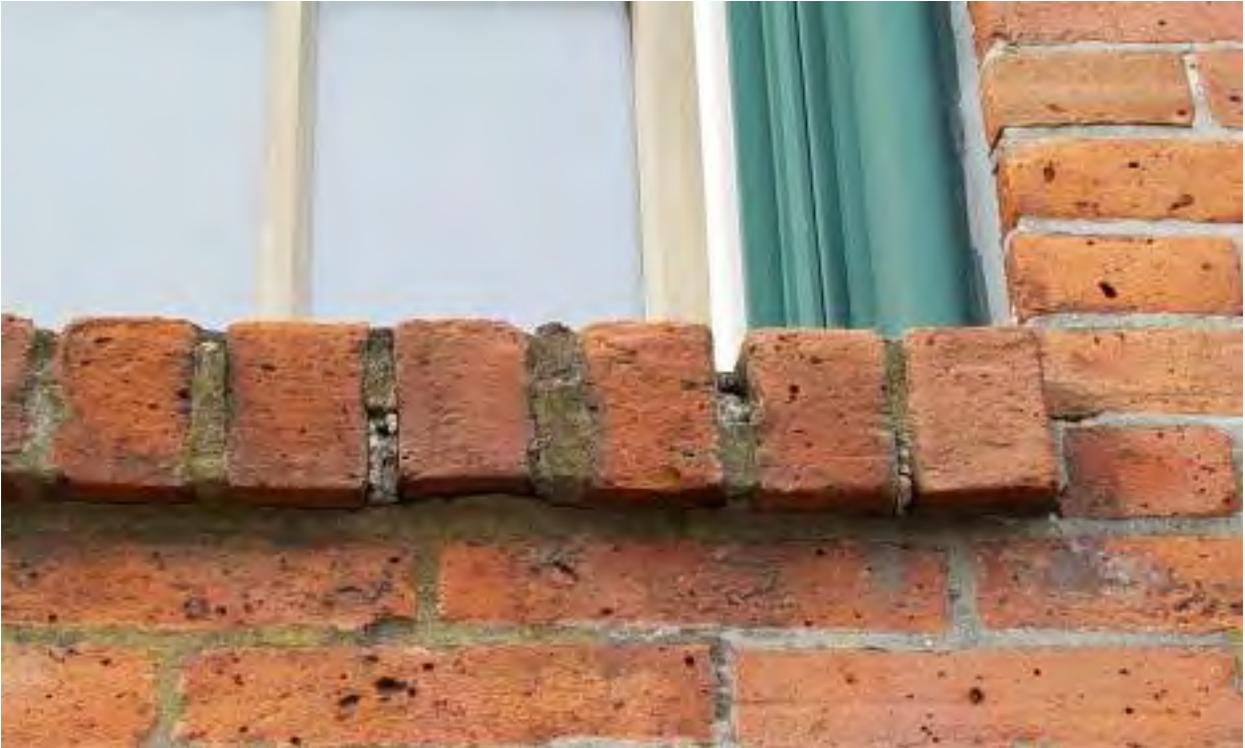
TYPICAL EXAMAPLE OF DETERIORATED ROXLOC BRICK SILLS

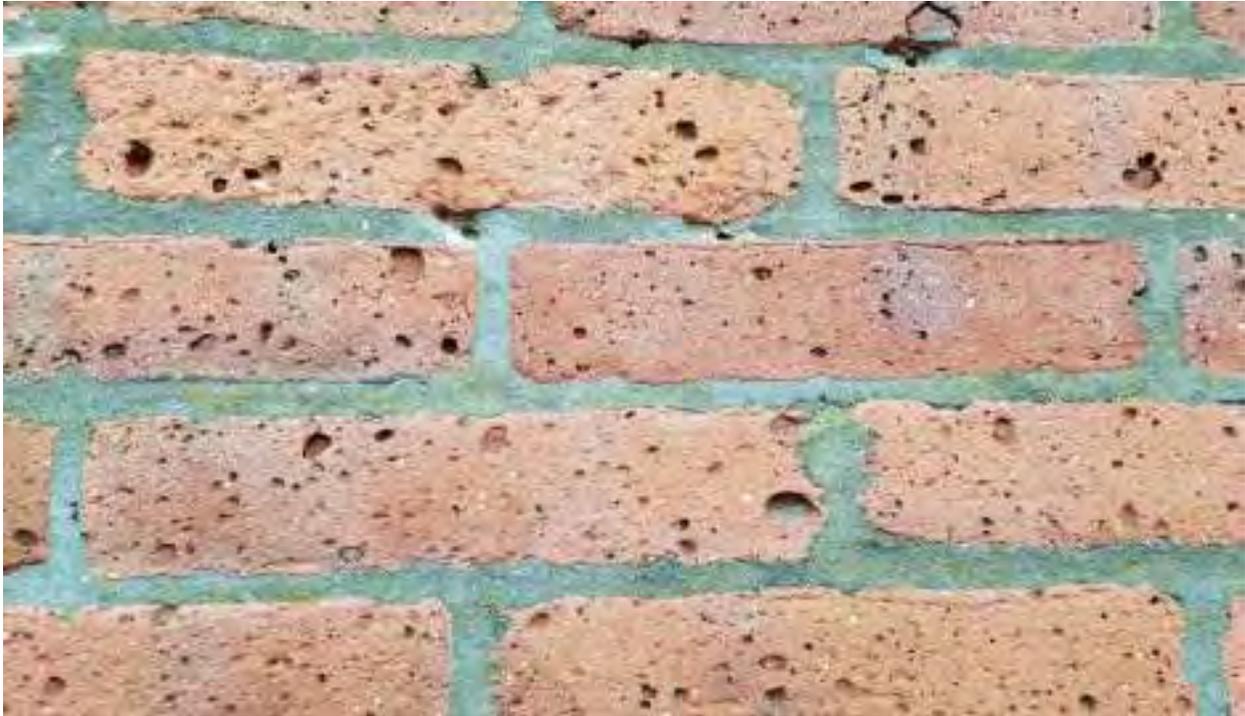
EXAMPLE OF EXTREMELY POROUS CONDITION OF EXISTING BRICK – SUSCEPTIBLE TO MOISTURE INFILTRATION AND FREEZE/THAW DAMAGE – ALSO ORGANIC GROWTH ON MORTAR

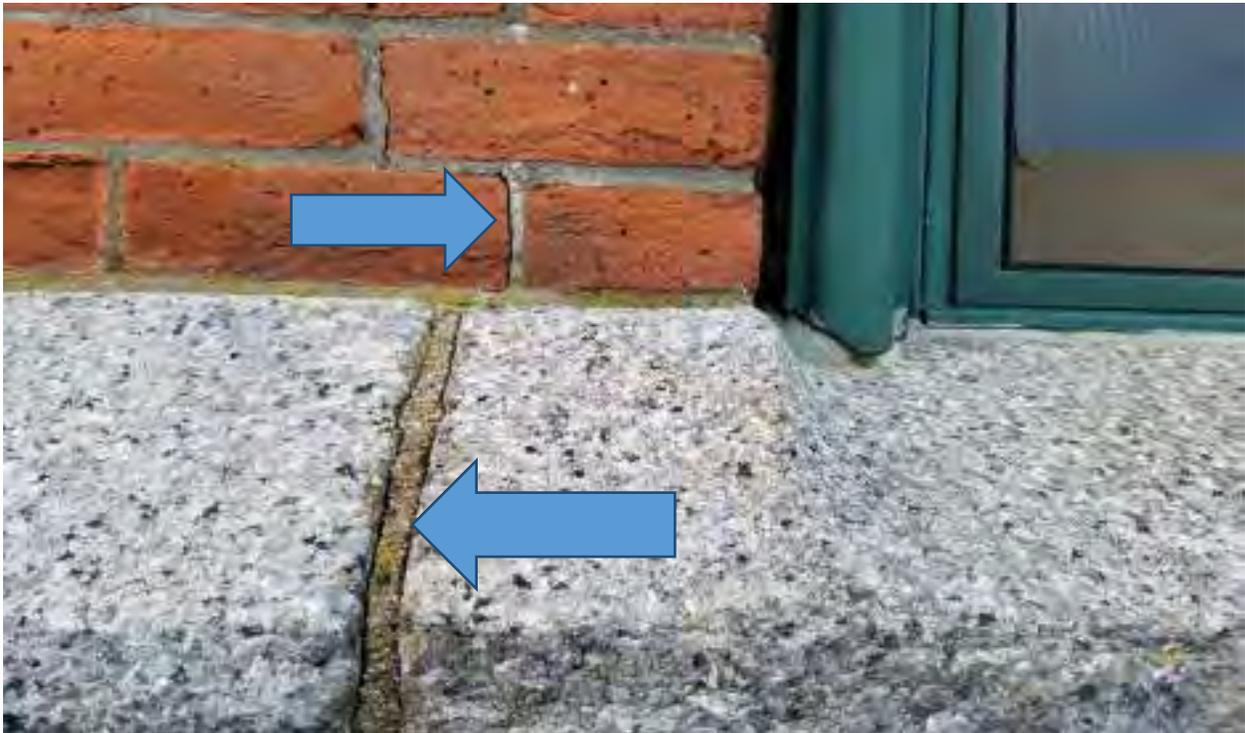
EXAMPLE OF OPEN JOINTS IN GRANITE SILLS and NOTE CRACKS IN MORTAR AT BRICK

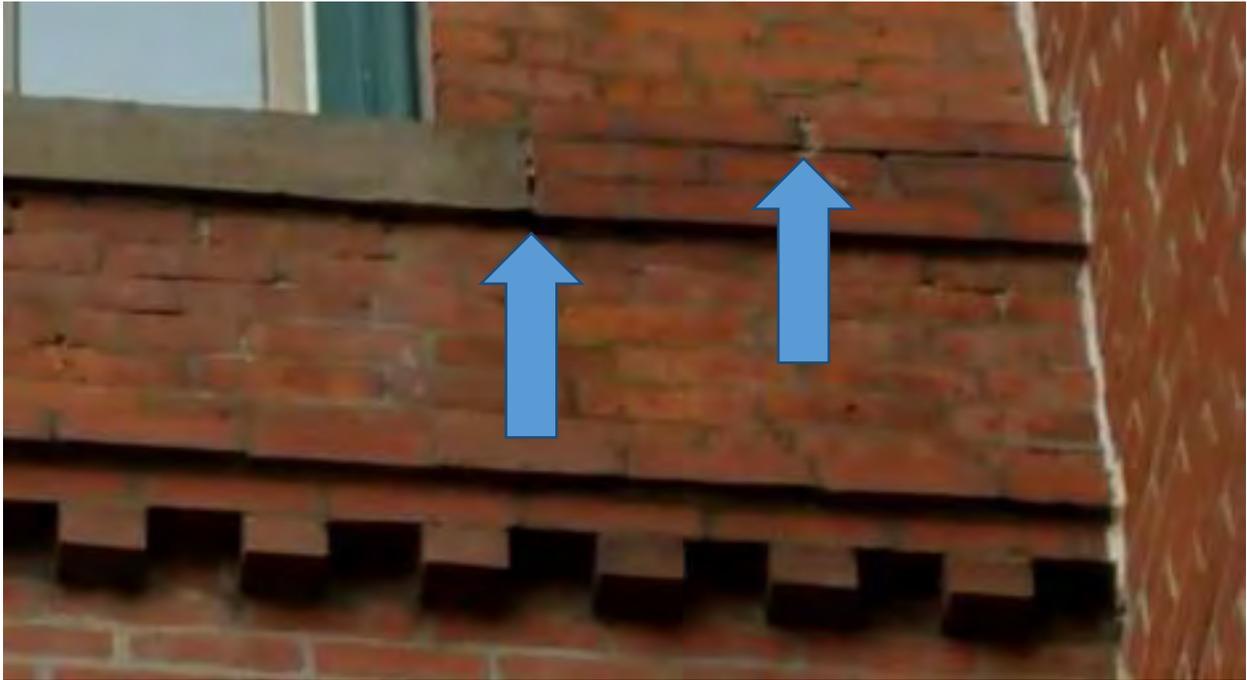
OPEN JOINTS IN BRICK/LIMESTONE

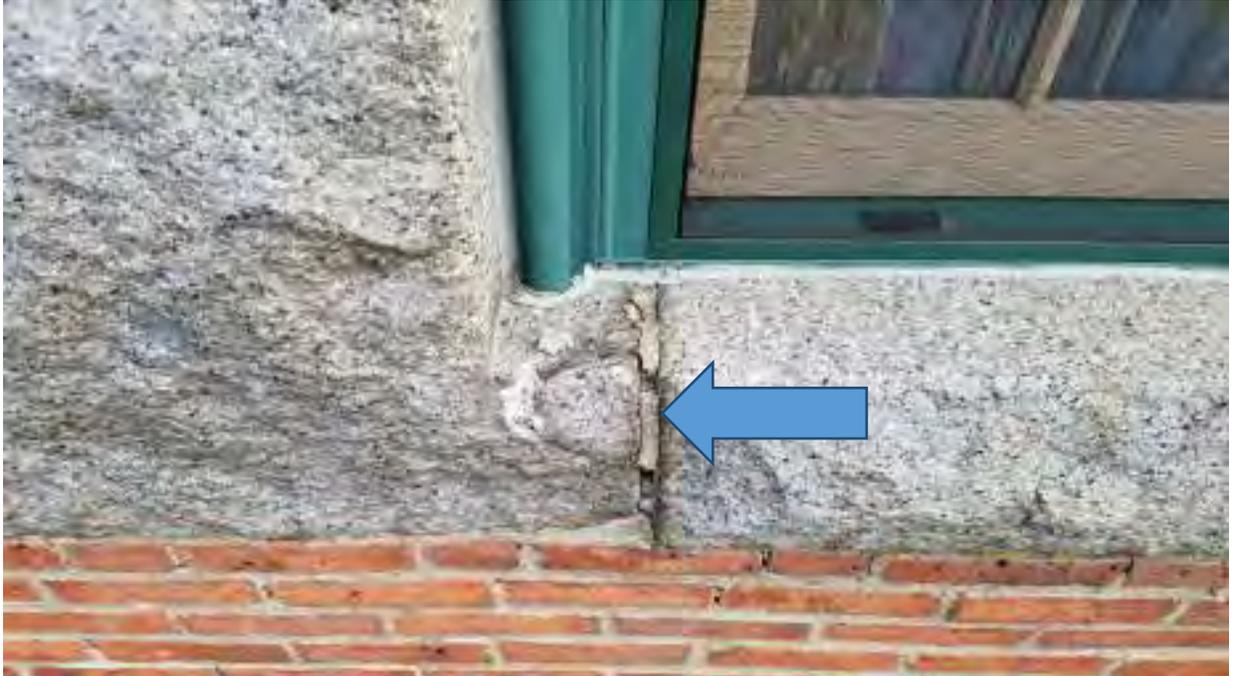
SHOWING REPOINTING NEEDED AT GRANITE SILLS

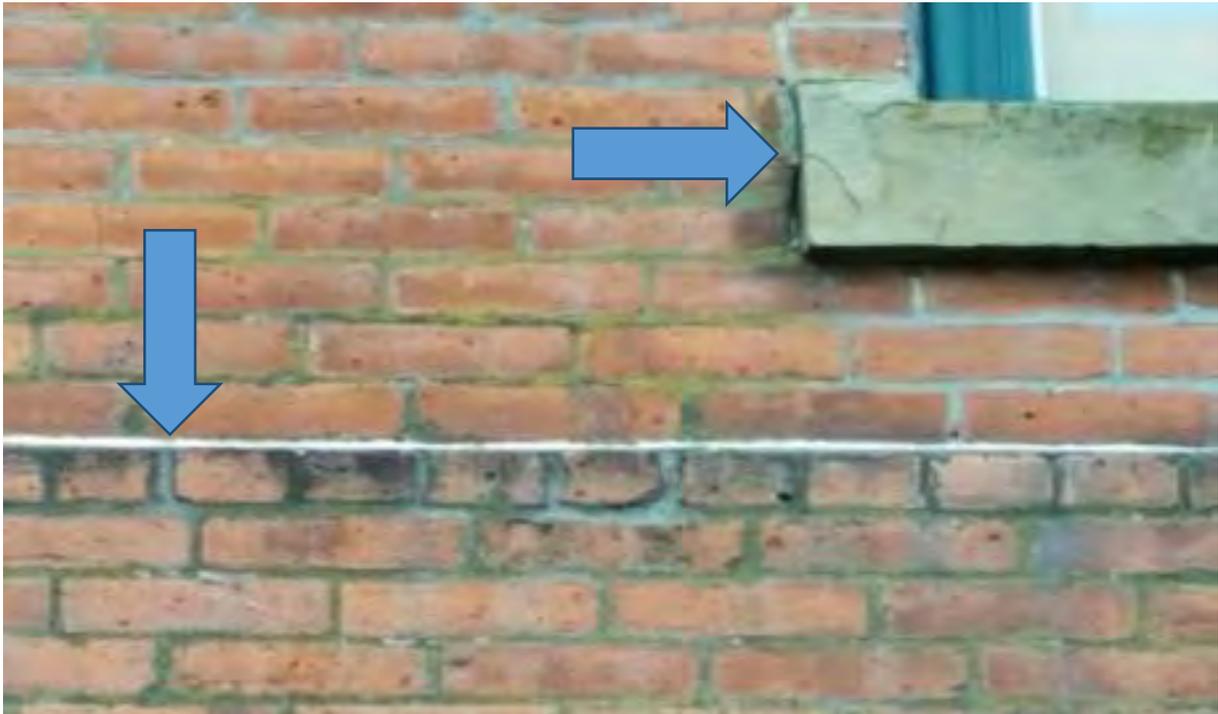
SHOWING POOR CONDITION OF LIMESTONE SILLS and CAULK JOINT ALONG TOP OF INTERMEDIATE BRICK WATERTABLE

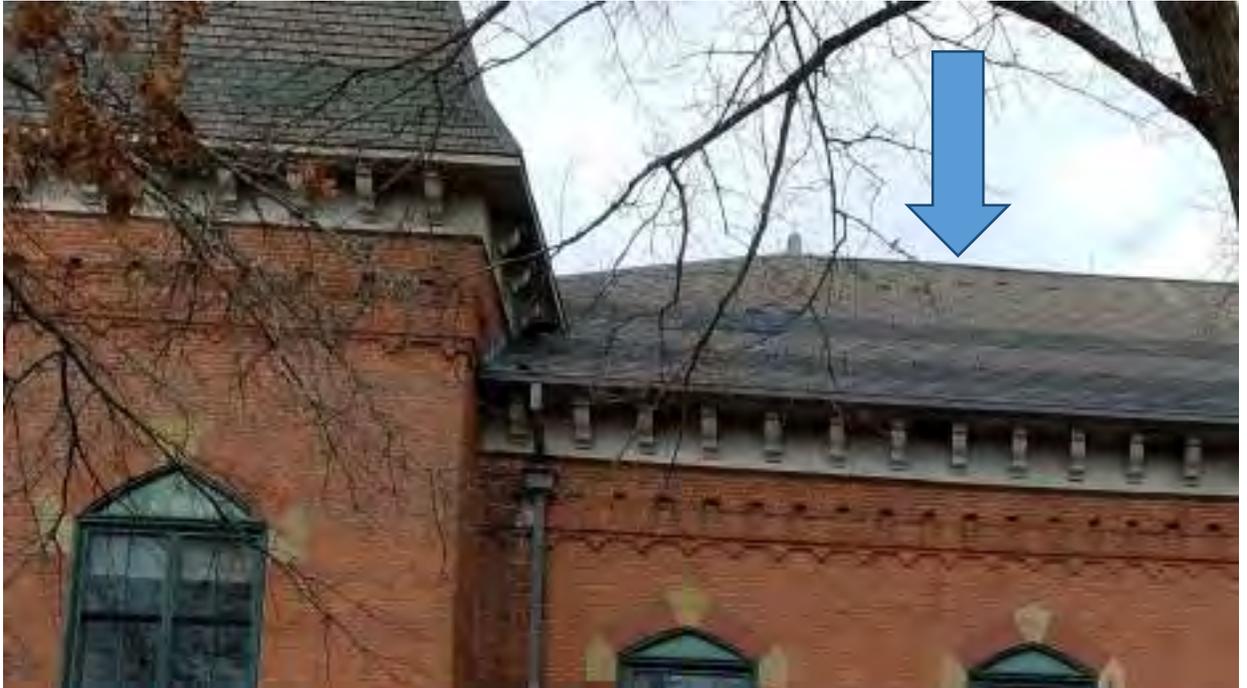
FRONT SHINGLED ROOF SHOWING MISSING SHINGLES

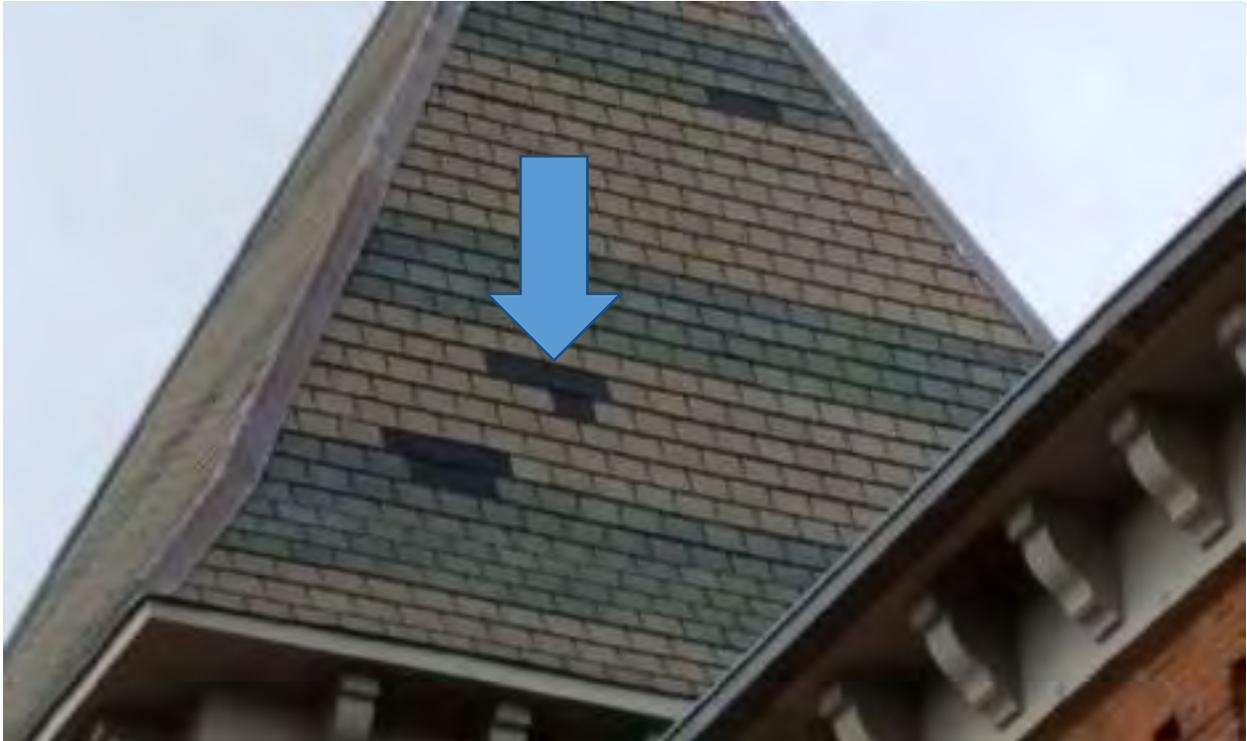
MISSING SHINGLES ON TOWER ELEMENTS

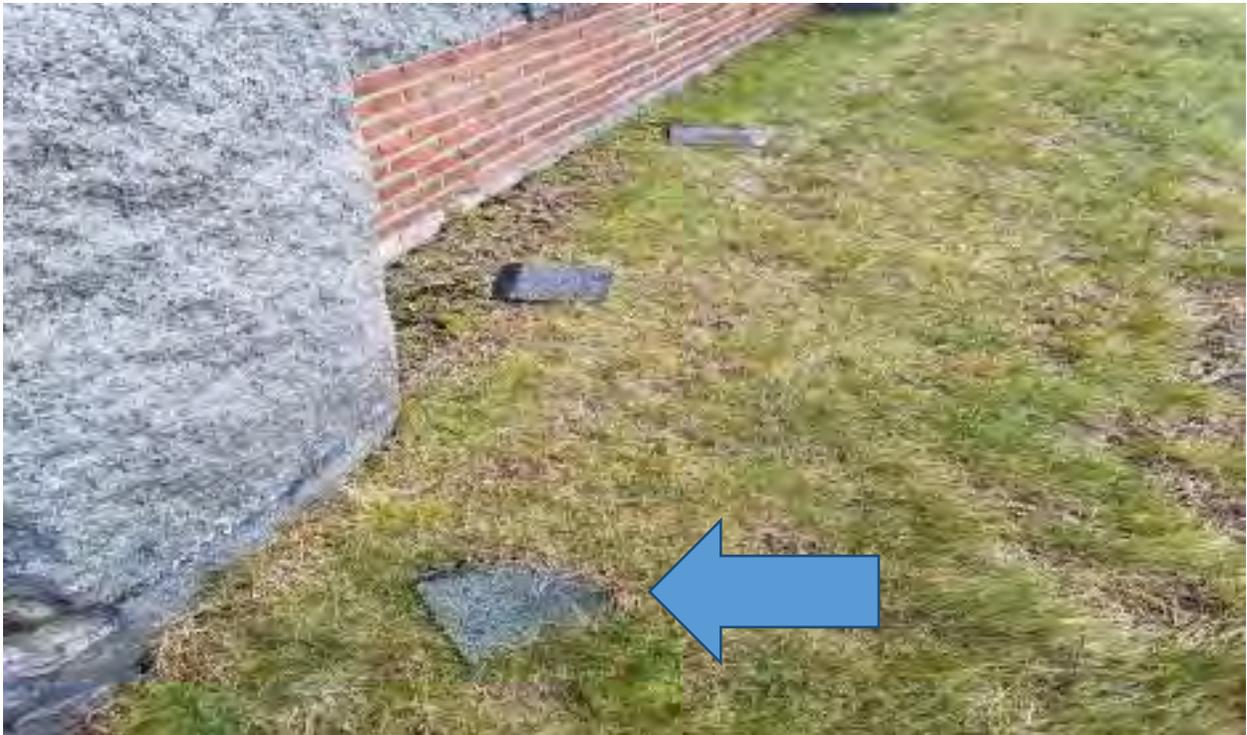
FALLEN ASPHALT SHINGLED SCATTERED AROUND BUILDING PERIMETER

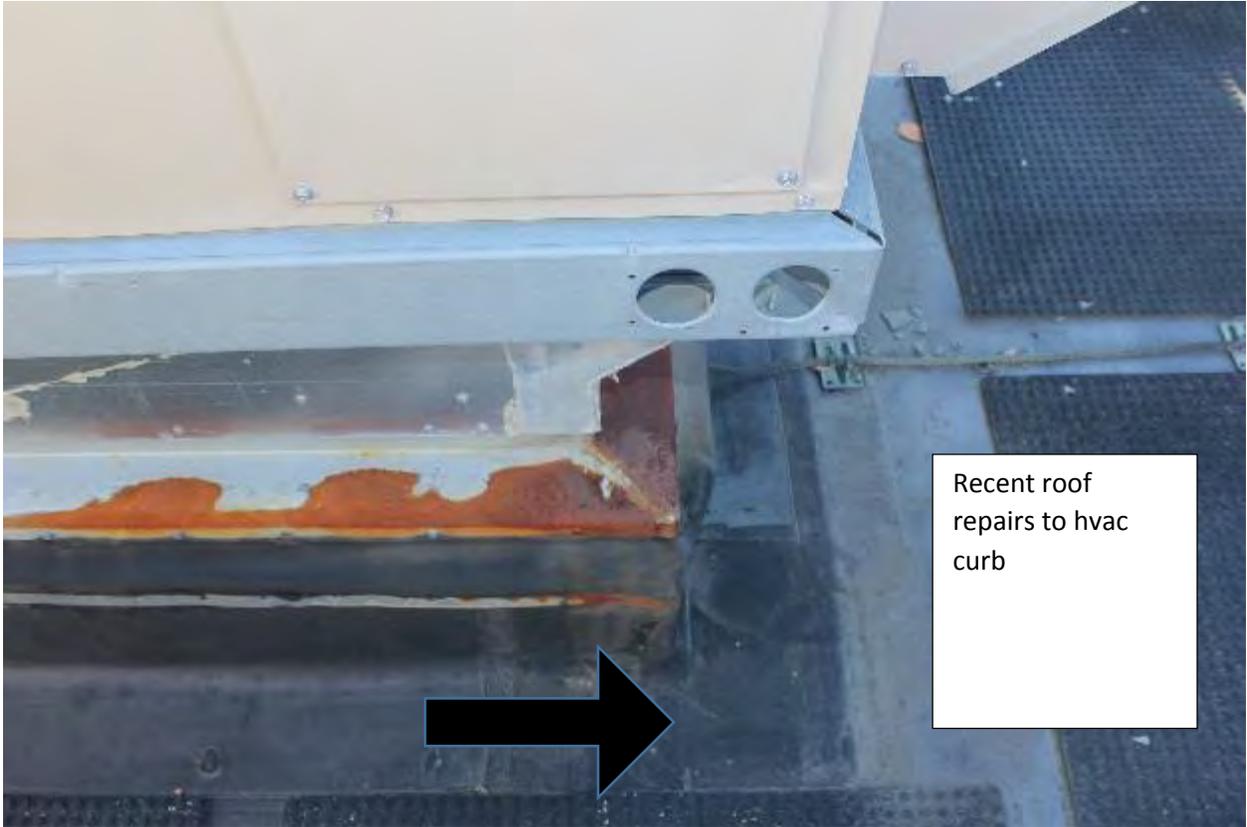
Recent roof repairs to hvac curb

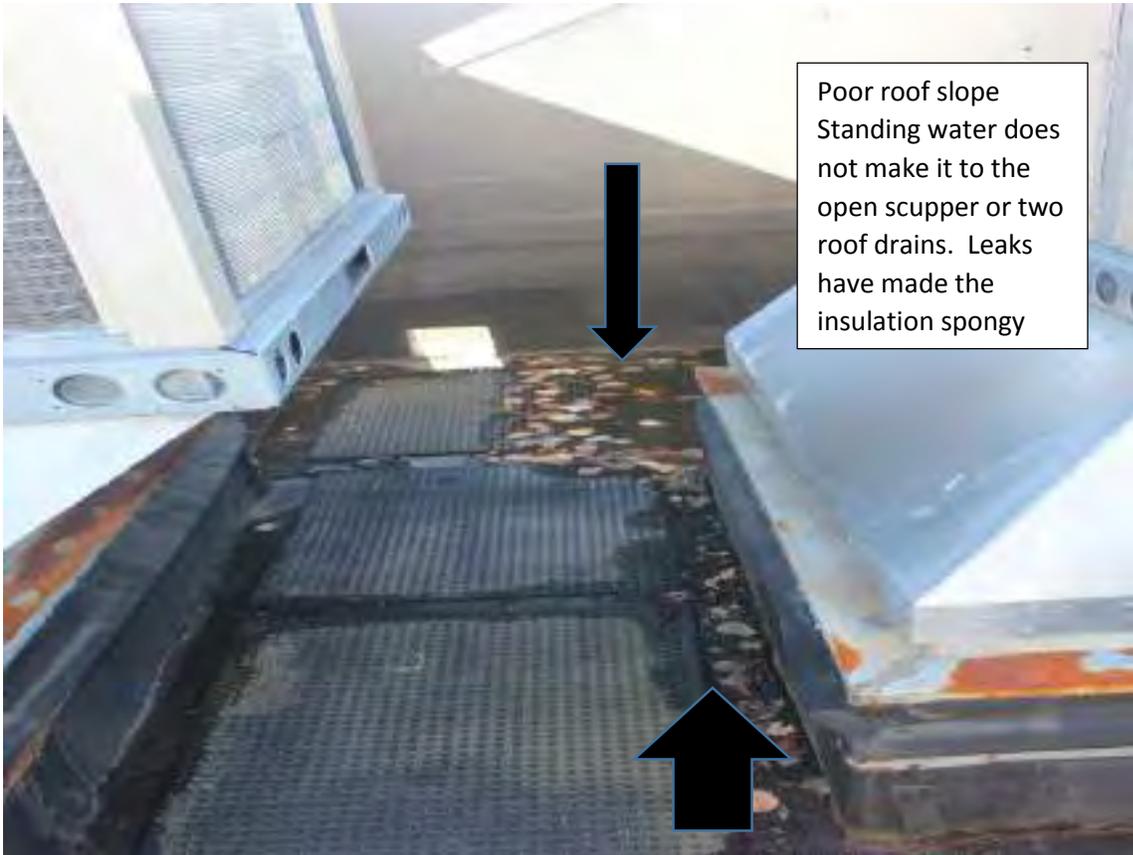
Poor roof slope
Standing water does not make it to the open scupper or two roof drains. Leaks have made the insulation spongy

Replace all EDPM roof areas \$45,000

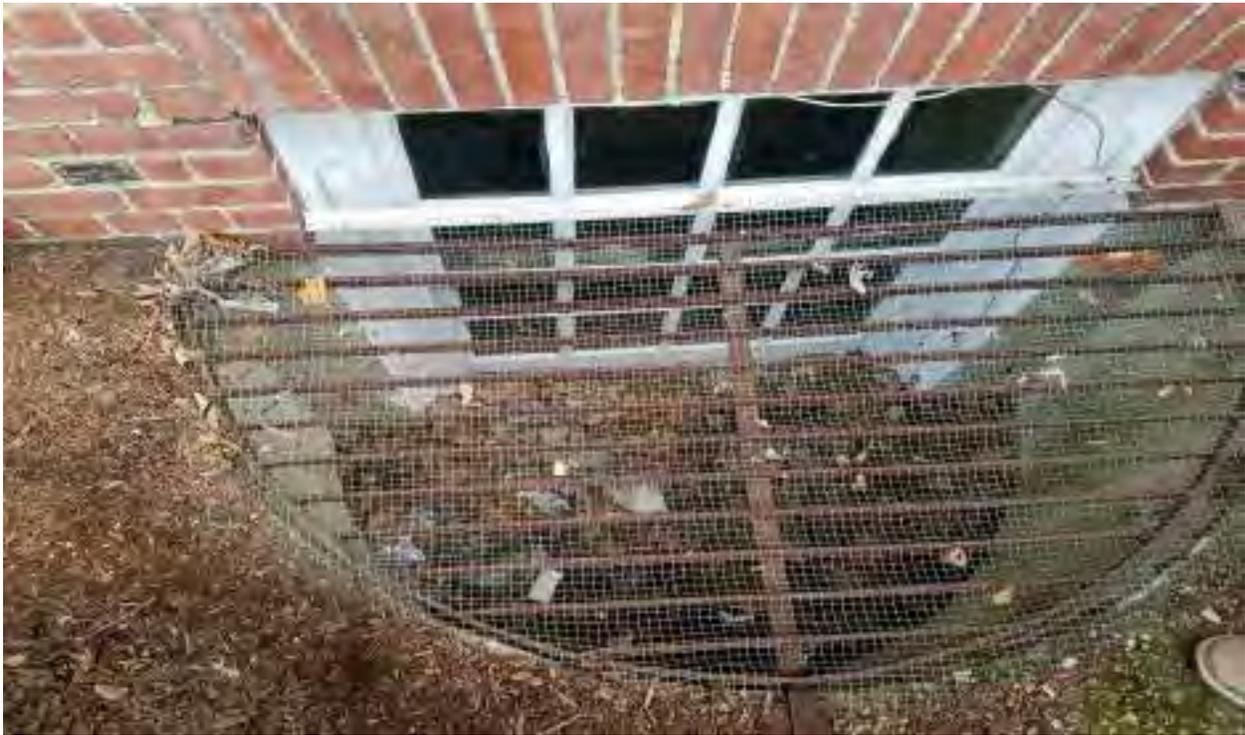
SHOWING TYPICAL AREA WELL NEEDING DEBRIS REMOVED

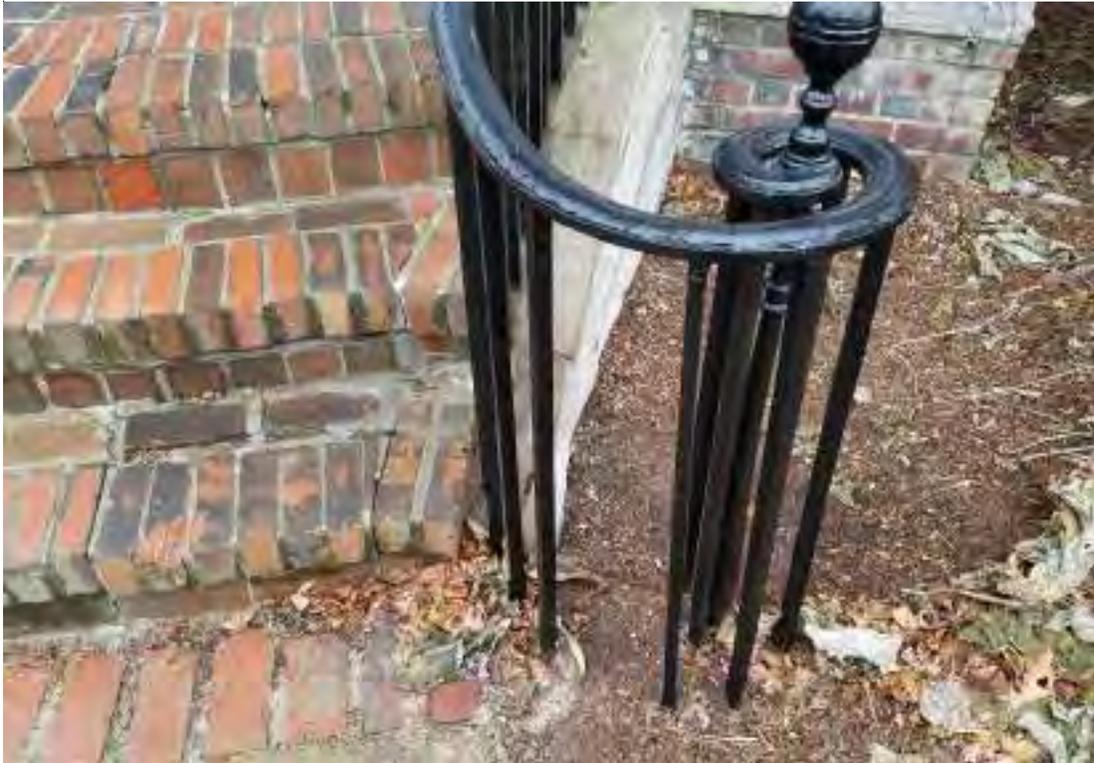
DETERIORATED BRICK STEPS AT ORIGINAL ENTRANCE STEPS (NORTH ELEVATION)

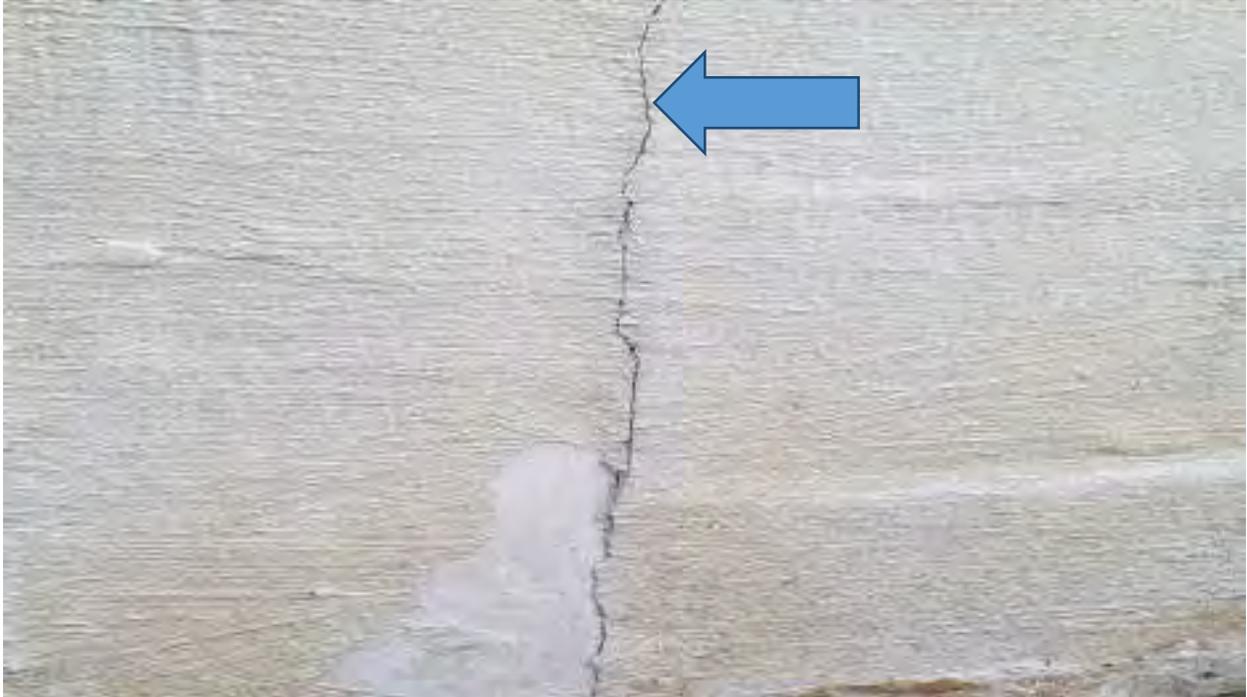
STUCCO PARGING IN EXTERIOR STAIRWELL NEEDING REPAIR and CONTROL JOINT

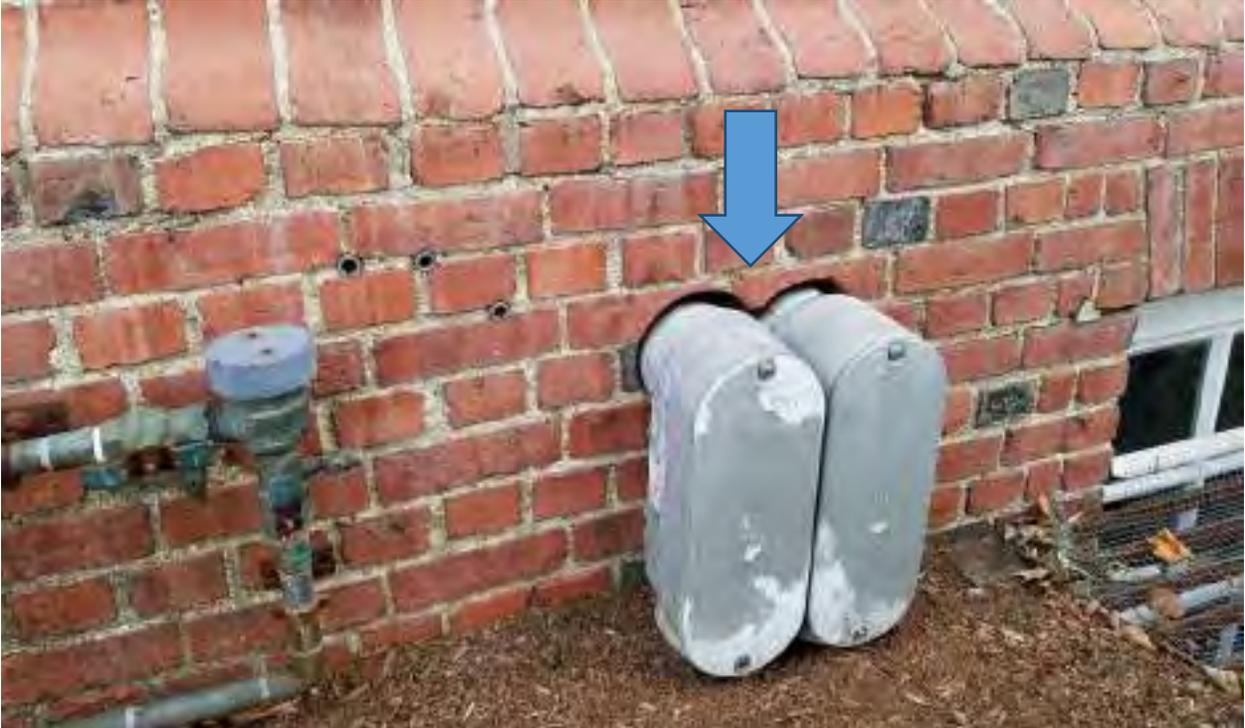
PROVIDE SEALANTS AROUND ELECTRICAL SERVICE PENETRATIONS (WEST)

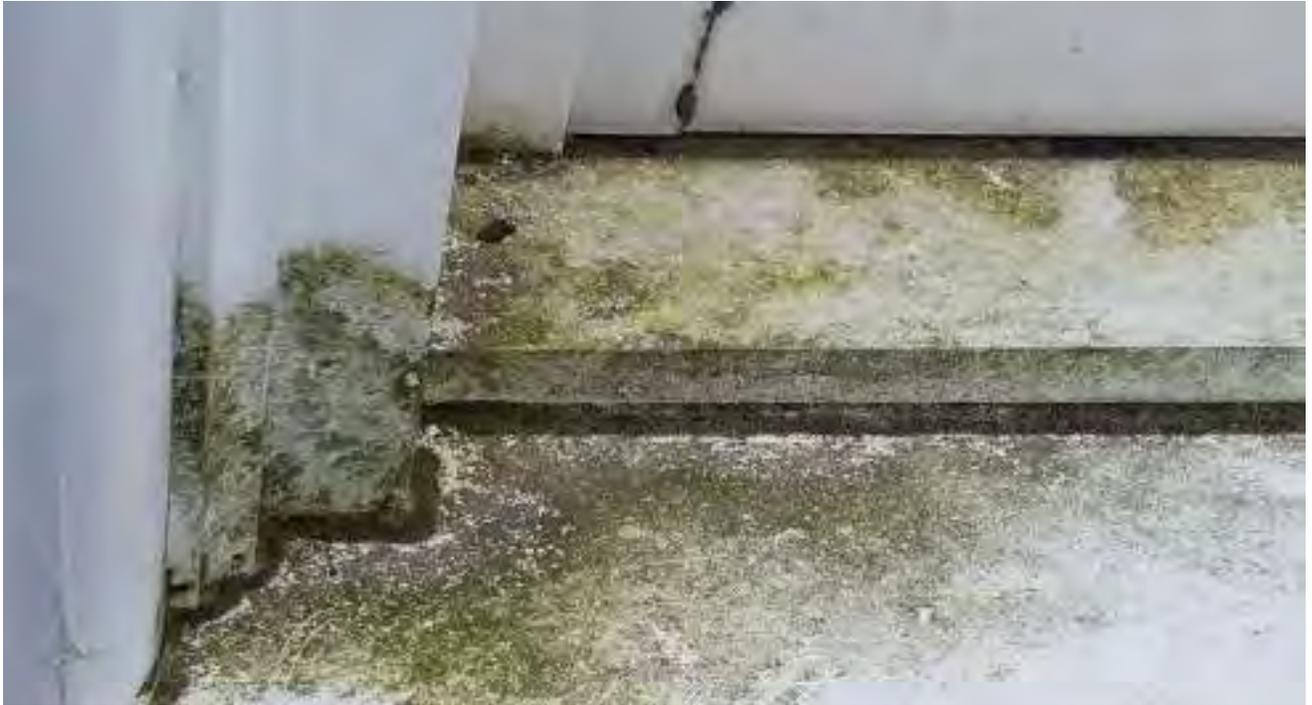
MILDEW & DETERIORATED SEALANTS SHOWN AT EASTERLY WINDOW UNIT WITH POSSIBLE REVERSE SLOPING SILL

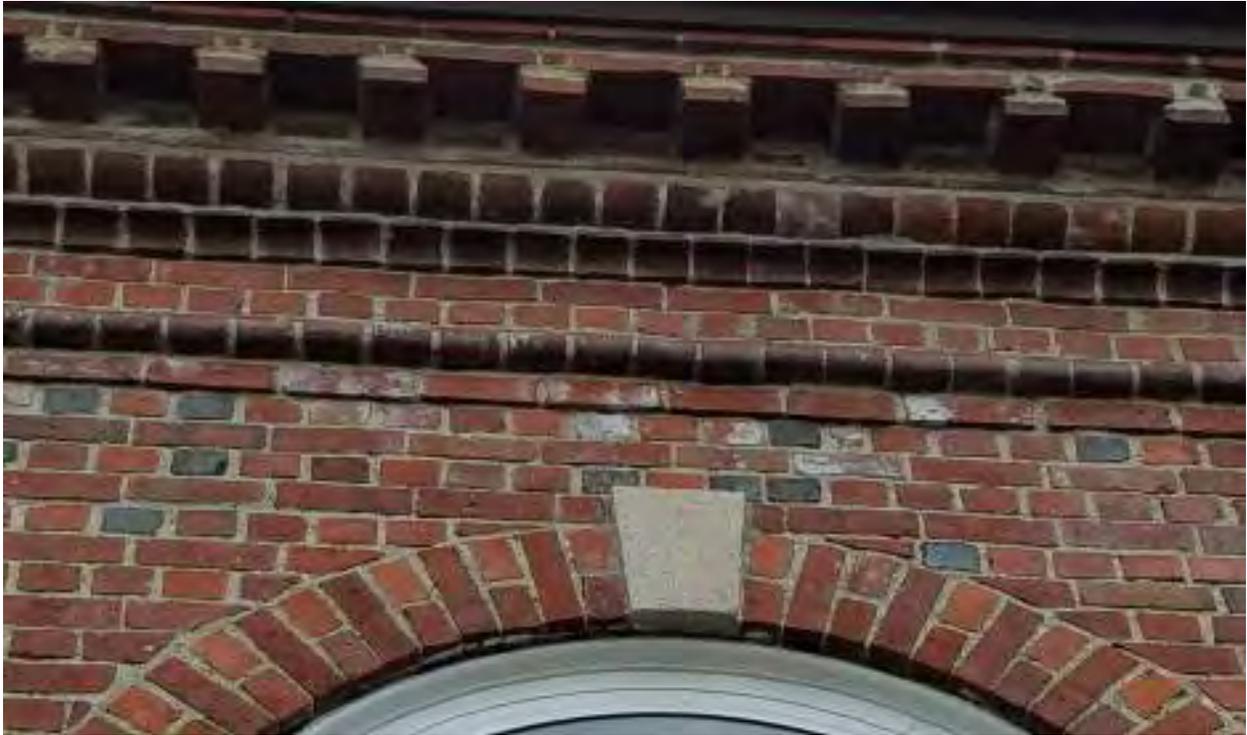
SHOWING POSSIBLE INFILTRATION ON WEST ELEVATION CAUSING EFFLORESCENCE

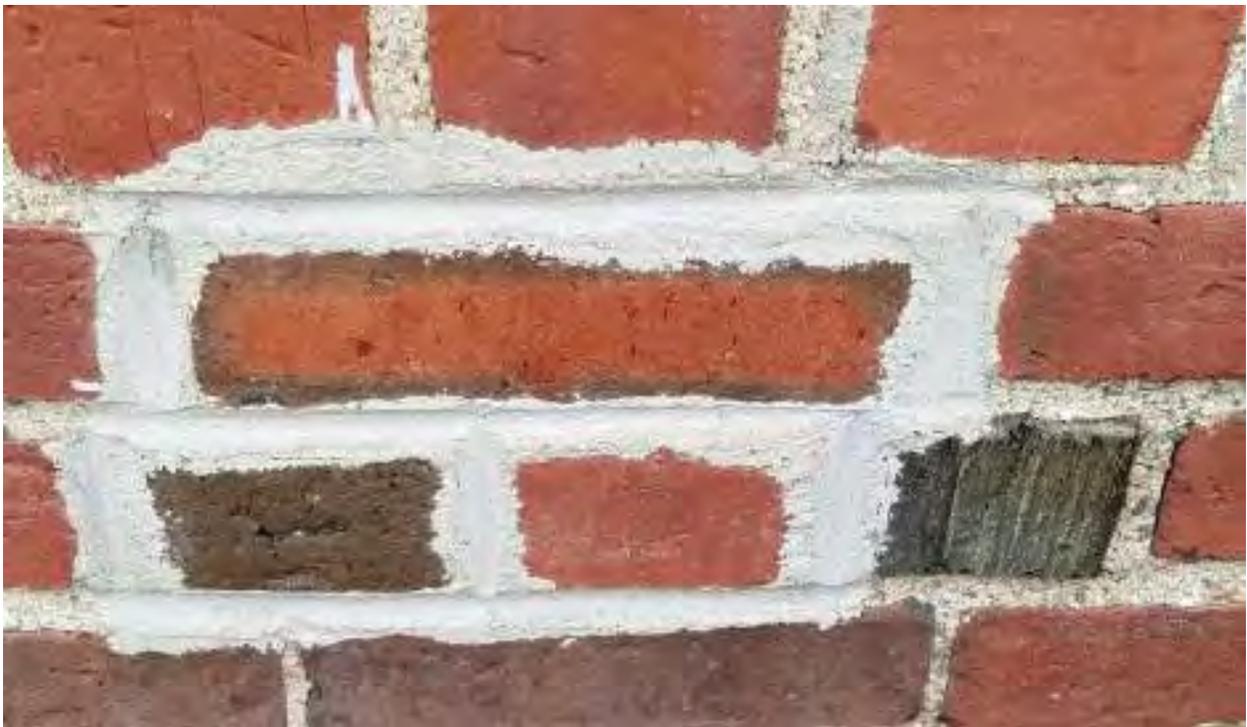
SHOWING POORLY EXECUTED REPOINTING DONE PREVIOUSLY (WEST ELEVATION)

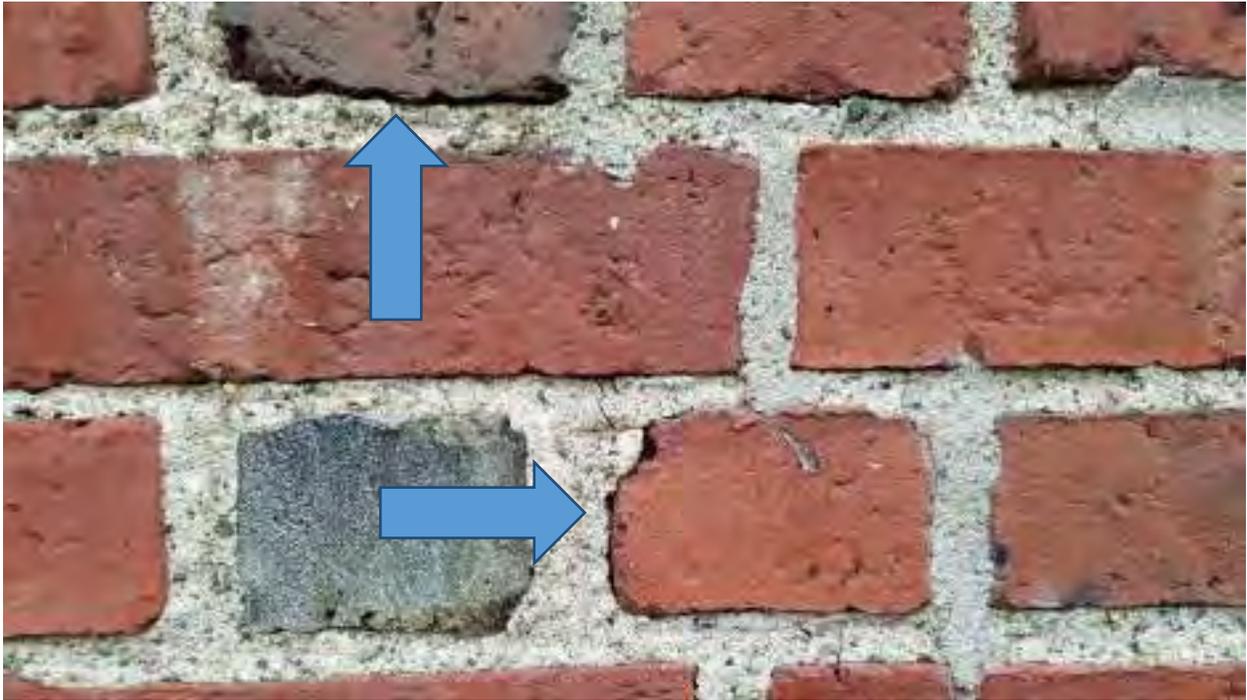
SHOWING TYPICAL JOINT DETERIORATION ON ORIGINAL BUILDING

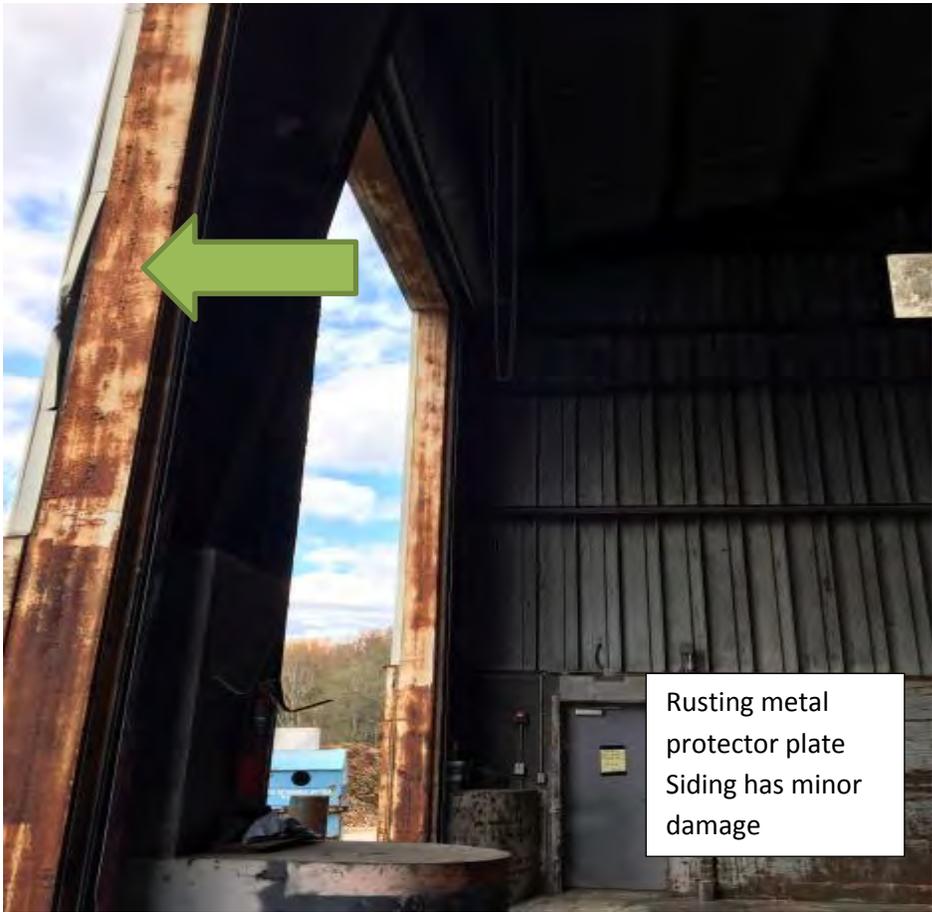
Rusting metal
protector plate
Siding has minor
damage
